SEISMIC RETROFITTING METHOD FOR STEEL STRUCTURES BY KNEE BRACES JOINTED BY HIGH HARDNESS VISES

Abstract. The authors have developed a new method of seismic retrofit for steel structures by adding knee braces which is jointed to the existing structures by vises with screw bolts made of high hardness metal. The slipping strength of the connection had been studied through axial tensile test of steel coupons jointed by the vises. The features of the connection by the vise are easy setup and providing the strength as much as by the normal bolts joint. An experimental study had been conducted for the specimens of steel frames retrofitted by knee braces. The knee brace was jointed to the steel frames by the vises. Two types of failure modes were investigated. One was slipping behavior at the connection and the other was buckling behavior at the knee braces. The strengths of the specimens were estimated by the simple calculations for the two types of failure modes.

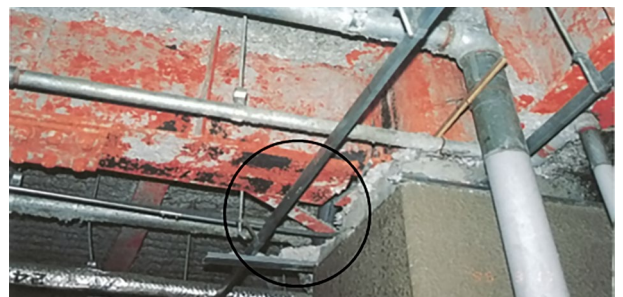
Figure 1. Steel structure damaged by Kobe earthquake in 1995

Buildings of steel structures were damaged by some large-scale earthquakes in Japan. The typical damage under strong ground motions was breaking along the welding line at the beam-column-connection as shown in Figure 1 (Architectural Institute of Japan [AIJ], 1996) and Figure 2 (Editorial Committee for the Report on the Hanshin-Awaji Earthquake Disaster, 2000). The earthquakes of 1994 Northridge and 1995 Kobe revealed that a large number of steel buildings experienced damage. To avoid the inconvenience and cost due to the damage by earthquakes, significant researches have been conducted on the approaches that enhance structural resilience. Fang et al. (2022) summarized some of the recent technological advances in the field of the seismic resilient steel structures. Among these, MacRae (2013) reported the various brace structures. The plastic deformation performance of steel dampers was investigated by Domenico et al. (2019), Kishiki et al. (2005) and Tamai et al. (2010) as the energy dissipating devices.

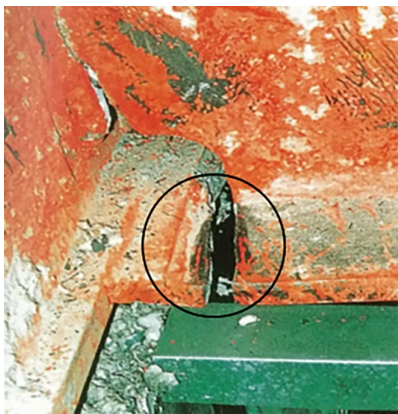
Figure 2. Fracture at beam-column-connection of the steel structure damaged by Kobe earthquake in 1995

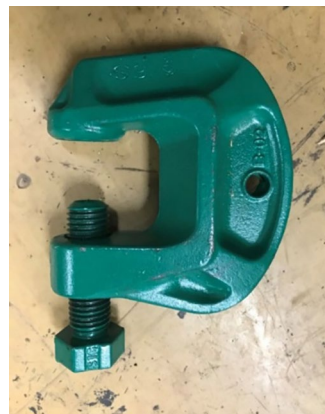
Figure 3. Vise used to seismic retrofit of steel structures

the bending moments at the ends of both of the beam and columns, and to increase the rigidity of the beam-column-connections. The knee braces are effective to prevent the damage of the beam-column-connections, but it is difficult to set them to existing buildings. The authors have proposed to use the vise which is shown in Figure 3 to clip the end plates of the knee brace to the existing beams and columns. There are no works for welding and making holes for bolts by using the vises to retrofit the steel structures. The head of the bolt of the vise is created as high hardness metal which bites into the jointed steel plates to prevent the loosening the torque of the bolt.

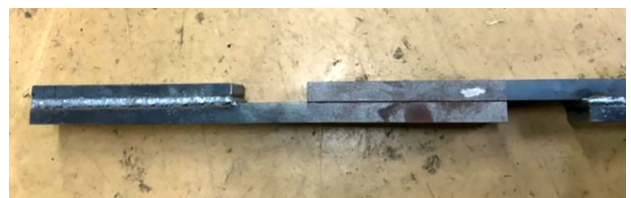
Figure 7. Specimens overlapped of two steel coupons

Figure 6 shows the shapes of the specimens. The rust and shot blast parts (50×180 mm) were shading in the figure. Test specimens were made by overlapping two steel coupons as shown in Figure 7. Then they were connected by the vise and subjected to tensile force.

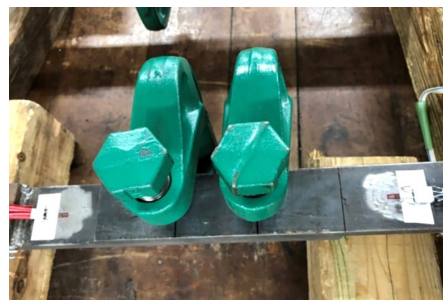
Figure 8. Specimen clipped by the two vises

The thickness of both of grip ends of the specimens were made as the same (i.e., the 11–16 mm specimen had 27 mm thickness of the grip ends). In the case of the different thickness of specimens, the bolt-heads of the vises touched on the thinner plates. Figure 8 shows the specimen clipped by the two vises as an example. The all bolts of the vise were introduced to 300 Nm torque by torque-wrench as shown in Figure 9. According to the torque of 300 kN, the average of the compressive force of the bolts was 75 kN.

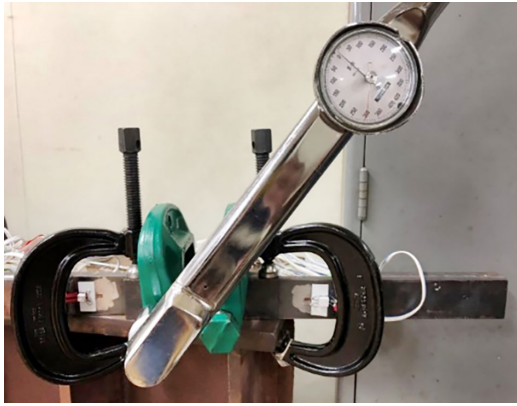
Figure 9. Introducing the torque of 300 Nm by torque-wrench

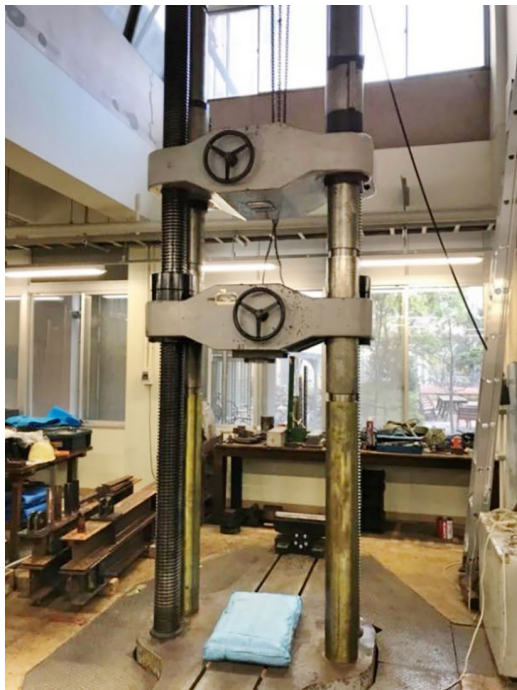
Figure 10. 2MN testing machine

Tensile test was conducted by using 2 MN testing machine shown in Figure 10. As shown in Figure 11, the test specimens were subjected to tensile force and measured the displacement between each steel coupon jointed by the vise by clip gauges in the gauge length of 57 mm. The measured displacement included the elastic deformation of steel coupon in the gauge length. It was necessary to subtract the elastic displacement from measured displacement to obtain the slipping displacement. After the test, the situations of the surface of the steel plates were recorded by the cameras, and the maximum torque was observed when the stress of the bolts were released.

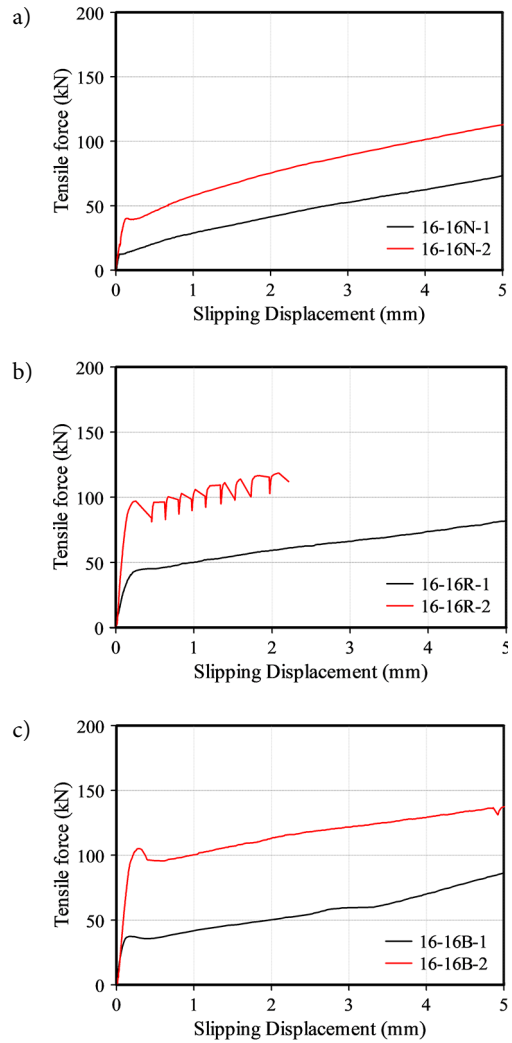
Figure 12. Relationships between tensile force and displacement: a - 16-16N; b - 16-16R; c - 16-16B

In the Figure 12, the test results of 16–16 mm specimens were shown as examples. The vertical axis showed the tensile force, and the horizontal axis showed the average of the slipping displacements observed by two clip gauges shown in Figure 10. In one figure, two curves were shown and compared by the difference of the number of the vises.

The Figures 10a to 10c were compared by the difference of the surface conditions. The slipping strength of the specimens with unprocessed surface were apparently lower than that of the specimens with rust surface and shot blast surface. The slipping behaviors occurred till 1 mm of the slipping displacement, then the tensile force increased gradually on all of the experimental curves. Figure 13 shows the surface of the steel coupon after the tensile test.

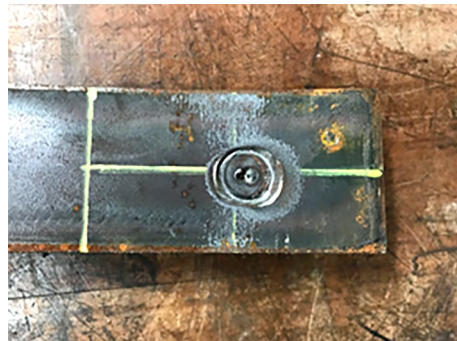
Figure 13. Surface of the steel coupon after the tensile test

The scratch mark by the high hardness screw bolt was shown in the photograph. The gradual strength enhancement was owing to the digging behavior of the bolt head into the steel coupon as shown in the photograph. The vise did not loosen the connecting performance between the steel plates after the slipping behavior occurred. The test results were already shown in Table 1. There are discussions for slipping displacement corresponding to slipping strength. The limits of displacements of slipping were defined as 0.2 mm in Japan (AIJ, 2016), 0.5 mm in U.S. (AISC-Research Council on Structural Connections, 1994), and 0.15 mm in Europe (ECCS Technical Committee 10. Bolted and Welded Connections, 1985), respectively. In this paper, the slipping strength was defined by the abrupt change of the slope of the experimental curve or tensile strength at slipping displacement of 0.2 mm. The averages of the slipping strength of three different surfaces were obtained as these values: 18.2 kN for un-processed, 35.5 kN for rust, and 37.7 kN for shot blast, respectively. The rust processing was available practically to use for seismic retrofit. The slipping strength of 35.5 kN by the vise was larger than the strength by high strength bolt (F8T, Japanese Industrial Standard, JIS) of M22, and smaller than that of M24, by referring to the Japanese Guide Book (AIJ, 2016). The frictional coefficient of rust surface became 0.47 which was 75 kN divided by 35.5 kN. This value was bigger than the value of 0.45 defined in Japanese recommendations (AIJ, 2006, 2010). This value of 0.45 was used for design for connection between knee brace and existing steel members, hereafter. There was no information of the loosening of bolt in the use of long-term. The authors have already conducted stress relaxation test, and the loosening was not observed. The detail of the results of relaxation test will be informed in our next paper.

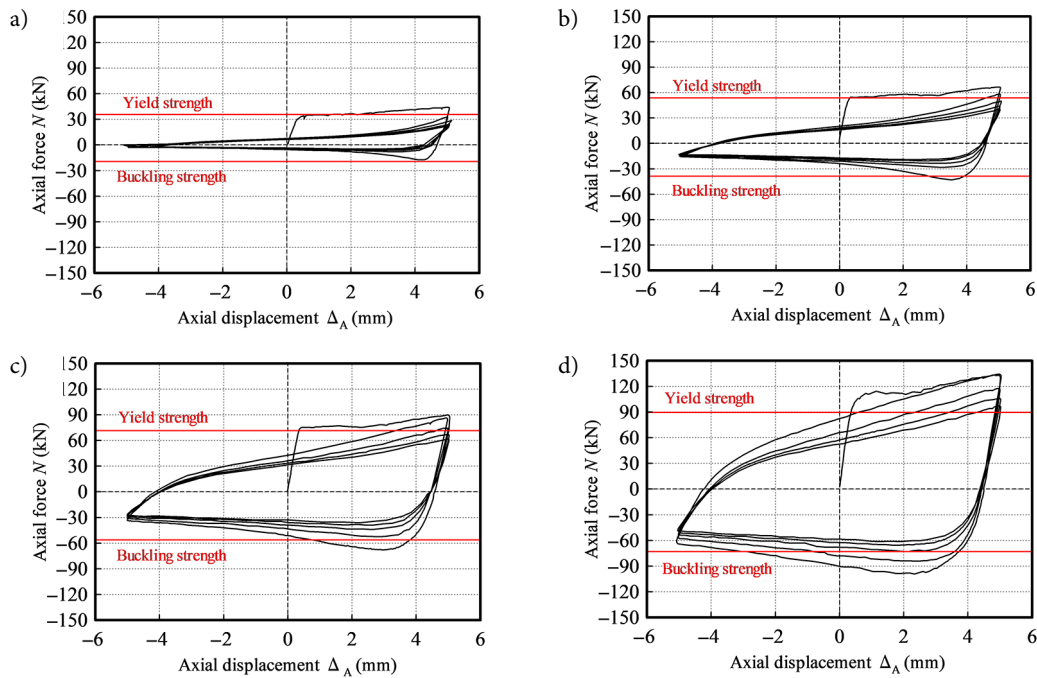
Figure 22. Relations between N and Δ_A : a – SL-45-1; b – SL-45-2; c – SL-45-3; d – SL-30

In this section, the test results of specimens which failed in yielding and buckling were discussed. In order to prevent the slipping failure, the four vises were used to connect the knee brace and steel beam. The axial force N corresponding to the calculated slipping strength by Eqn (2) was 135 kN. Figures 22a to 22d showed the relations between N and axial displacement Δ_A of the knee braces. The test was controlled by the axial displacement. The loading program was shown in Figure 23, where the maximum displacement was 5 mm. The value of N was obtained from rotational equilibrium.

As shown in the figures, the knee braces attained its yield strength under tensile force. After that, buckling of the knee braces occurred under compressive force. The redlines showed the calculated yield strength and buckling strength in these figures. The experimental values and calculated values agreed precisely. The value of N of all specimens did not attain the 135 kN which was strength of slipping failure. The comparisons between test and calculation were summarized in Table 6. The yielding and buckling mechanism at knee braces was desirable. In this test, the mechanism at knee braces was realized. The load versus deformation relations were discussed deeply from test and analysis in our next paper.
