## INFRARED THERMOGRAPHY FOR DETECTING DEFECTS IN CONCRETE STRUCTURES

Gene F. SIRCA Jr., Hojjat ADELI\*

This paper presents a state-of-the-art review of the Infrared Thermography (IRT) research for detecting defects in concrete structures. IRT remains a promising technology for economical health monitoring of structures. The article encourages researchers to apply the IRT technology for health monitoring of large concrete structures. The success of IRT to detect defects or damage in large concrete structures would be a major breakthrough in NDE inspections of large structures such as dams and cooling towers as traditional methods are very costly and time consuming.

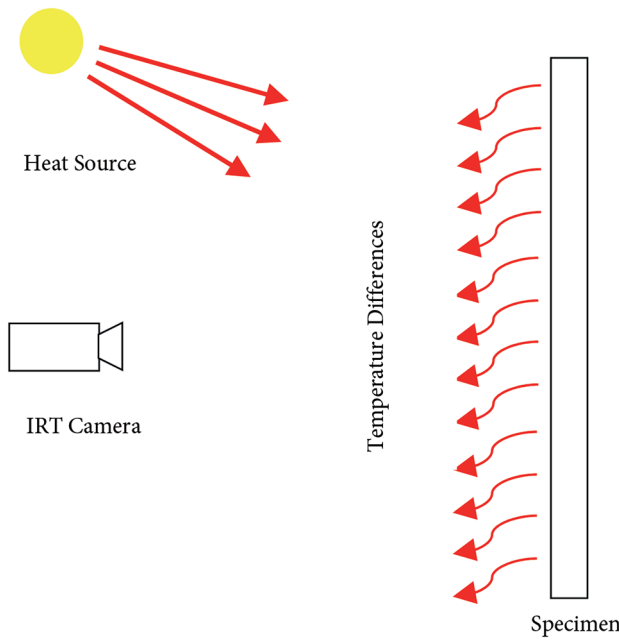
Figure 1. Typical arrangement of equipment for flash thermography

it emits radiation in the long-infrared range of the electromagnetic spectrum which is detected by a thermographic camera. Figure 1 shows a typical arrangement of heat source and IRT camera to record thermal images. Note that the typical heat source for large structures is direct sunlight (often referred to as “flash thermography”). However, some research has shown that adequate ambient temperature change is often sufficient to detect defects (Guimaraes 2014).

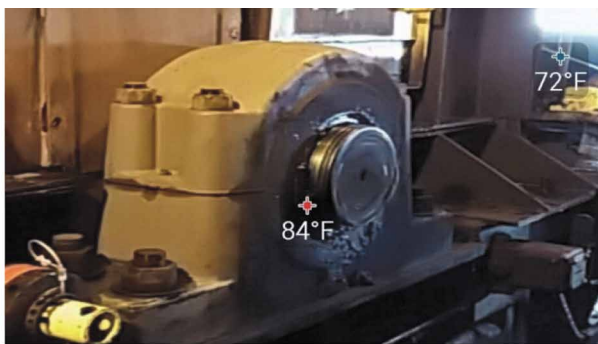
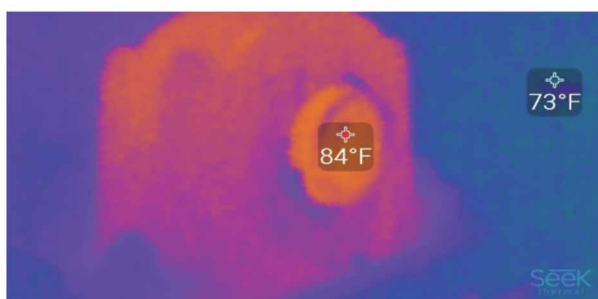
Figure 2. Thermal image of a pillow block bearing

Some of the common commercial uses for IRT include inspecting mechanical and electrical components such as bearings, gearboxes, electrical bus bars, and for detecting heat loss in buildings. To illustrate, Figures 2 and 3 show IRT images of a pillow block bearing and gearbox, respectively, those were taken by the first author as part of a mechanical inspection. The spectrum of color in such photos indicates the temperature at the surface ranging from white for the hottest to black for the coolest with other colors, yellow, orange, red, purple, and blue falling

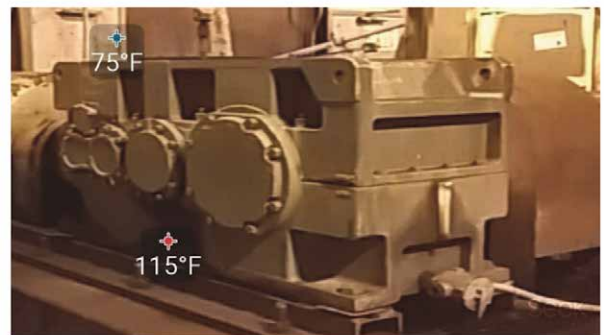
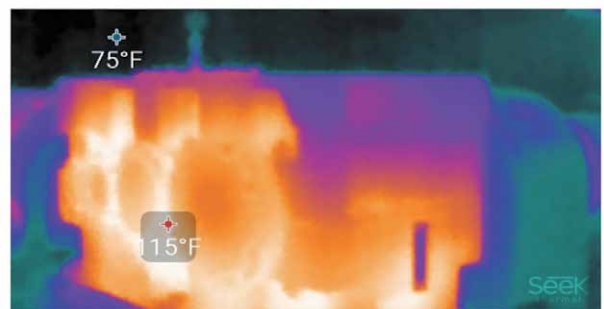
Figure 3. Thermal image of a gearbox

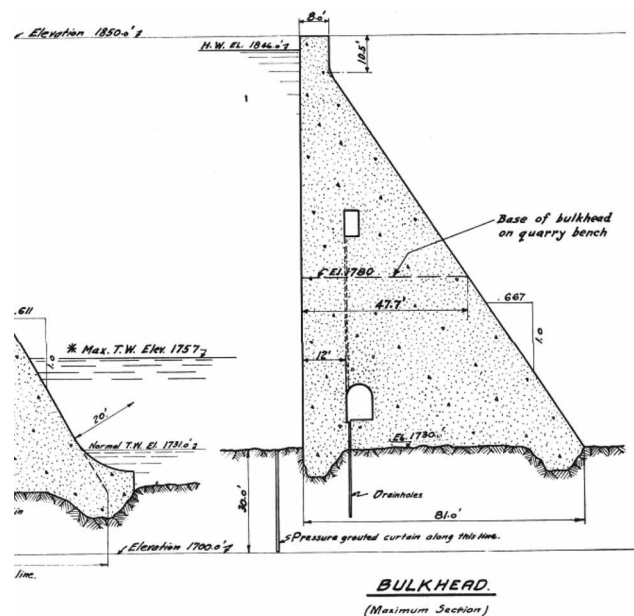
Figure 7. Claytor Hydroelectric dam cross section (from civil drawing provided by AEP)

Examples of large civil engineering concrete structures for IRT applications include hydroelectric dams (Figure 4), electric power plant cooling towers (Figure 5), and bridge decks (Figure 6). Figure 4 shows the American Electric Power’s Claytor Hydroelectric facility located in Western Virginia which is an unreinforced concrete structure with a typical cross section shown in Figure 7.

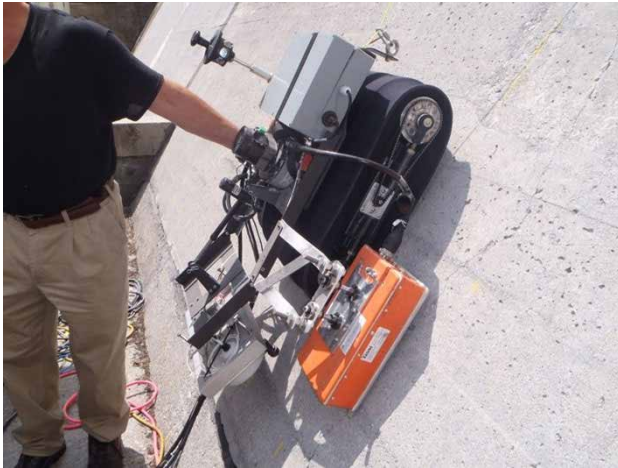
Figure 8. Experimental robot crawler used for NDE of Claytor dam

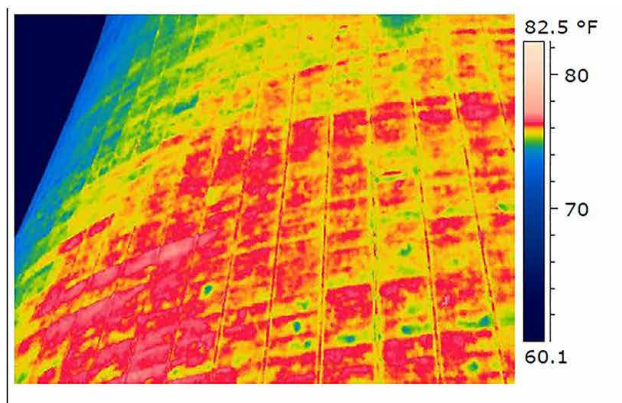
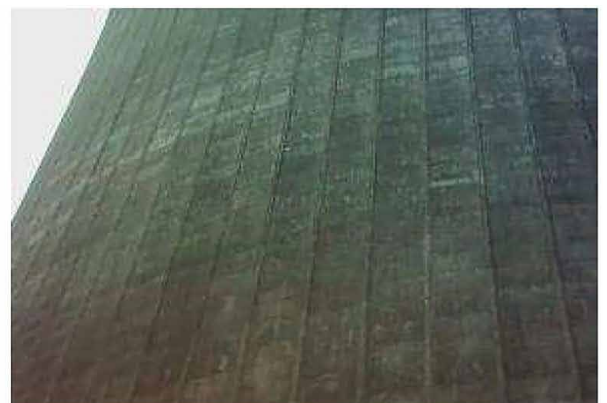
Figure 10. a) Thermal image of a cooling tower at Amos plant located in central West Virginia; b) The visual image

The dam was a test subject for implementing several NDE techniques, one of which was IRT (Guimaraes 2014). Other NDE techniques that were considered include ground-penetrating radar and air-coupled impact-echo testing which were mounted on a remote controlled robot that crawls on the surface of the dam. The robot “crawler” is shown in Figure 8. Another type of dam structure is the double-curved Smith Mountain dam depicted in Figure 9. Figure 10 shows a thermal image taken of a cooling tower at Amos power plant in central West Virginia. The visual

image is shown next to the thermal image for comparison. These structures are part of current research being performed by the authors of this review article.

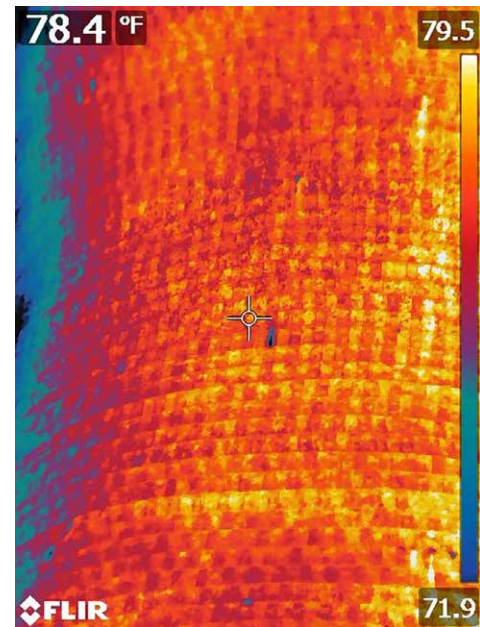
Figure 11. Thermal image of the north face of a cooling tower at Mitchell plant located in north-central West Virginia

cooling towers. However, IRT is currently being explored by American Electric Power (AEP) as an experimental tool for detecting defects. Figure 11 presents a thermal image from one of the cooling towers that is the subject of on-going research by the authors and AEP. New post processing techniques are currently being developed to detect defects. The research is also being extended to two of AEP's hydroelectric facilities: Claytor and Smith Mountain, as mentioned previously in this article. A sample thermal image from Smith Mountain dam is presented in Figure 12.

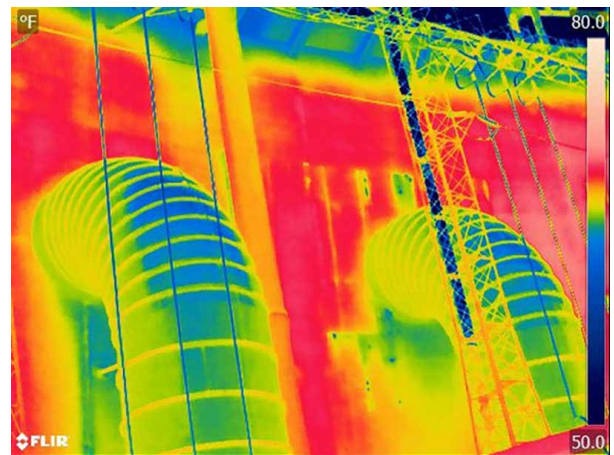
Figure 12. Thermal image of Smith Mountain Dam
